Clark Fork Drift Facility Update

Albeni Falls Dam Operating Project Manager

4 OCT 2019

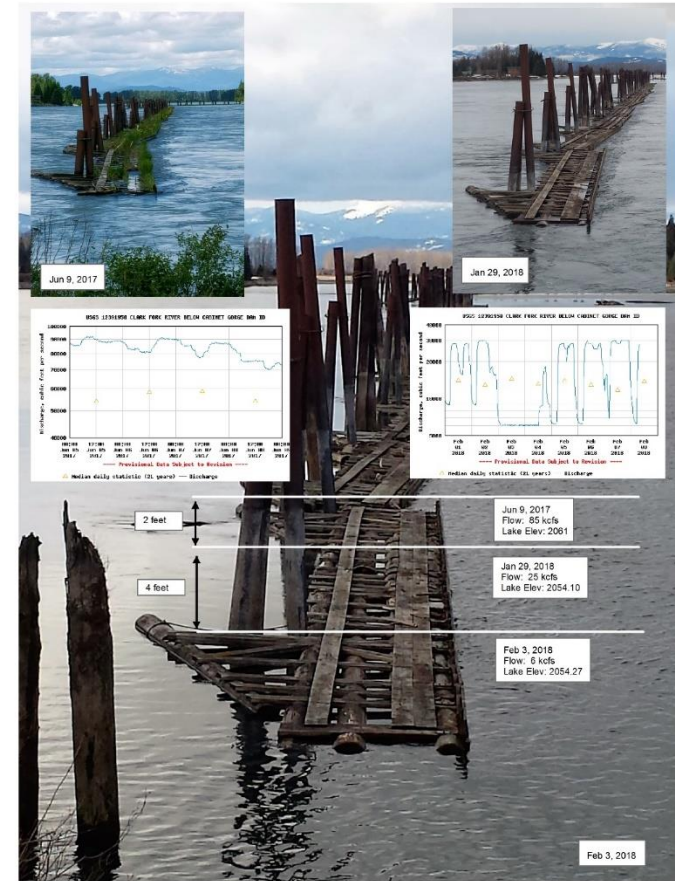
Age – It is unknown how old all of the components are; however it is known most date to original construction. Rotting, loosening and breakage of parts, waterlogging, rusting, and vegetative growth contribute to deterioration of components.

Vandalism – Components have been repaired that appeared to have been damaged by vandalism.

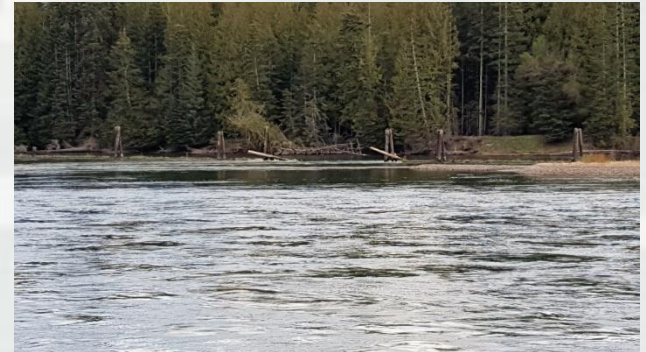
Buildup around booms increase river flow through the boom at other locations. The additional weight and flows force the boom to invert and subsequently fail.

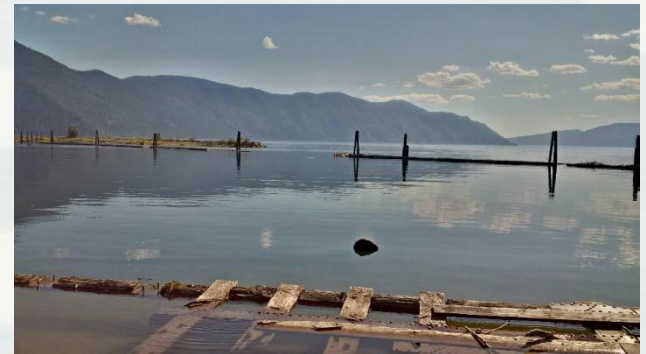
Wing and waves cause the boom to fail due to forces on aged and fatigued parts.

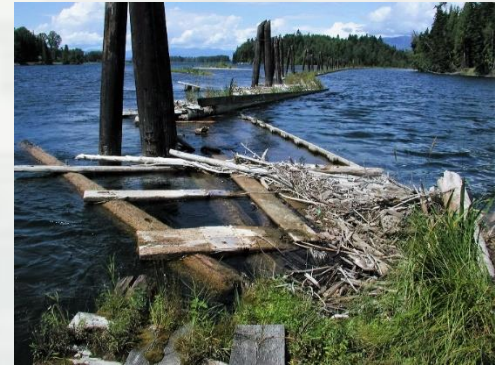
Waterlogging causes the boom to ride lower in the water, creating a condition in which drift builds on the boom instead of floating downstream the current. Weight of debris impacts boom function.

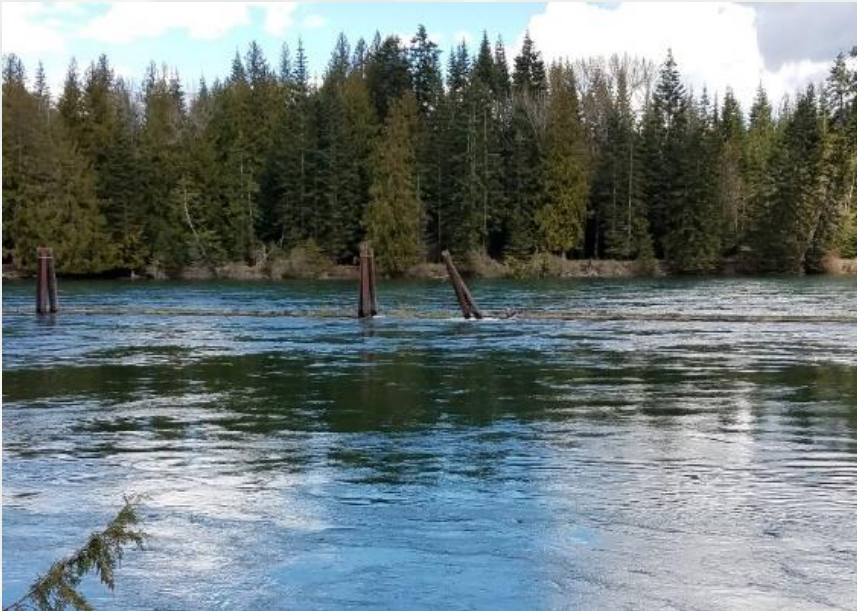
Dolphin Damage - Parts failing. Ex. One piling broke and the other two were twisted downstream. (note: This dolphin completely failed in 2017 and has been replaced)

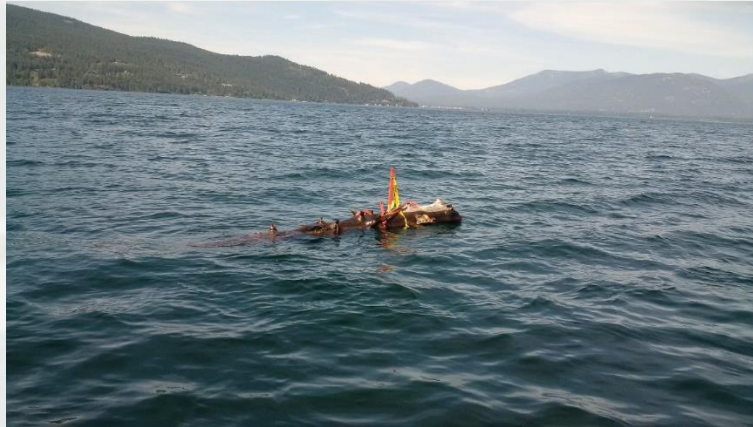
Debris release into the lake, 2016 – the boom 55 break released an estimated 100' by 100' (10000 sq ft) amount of material into the lake including debris ranging from sticks to logs, with an estimated 30 logs significant enough in size to be considered serious navigation hazards. Within three days the debris field had expanded into the lake to cover over 2700 acres. It is estimated that a full debris release from the driftyard, in volume of material, would be 112 times greater than that released in the June 28 event.
