Clark Fork Drift Facility Update

Albeni Falls Dam Operating Project Manager

4 OCT 2019

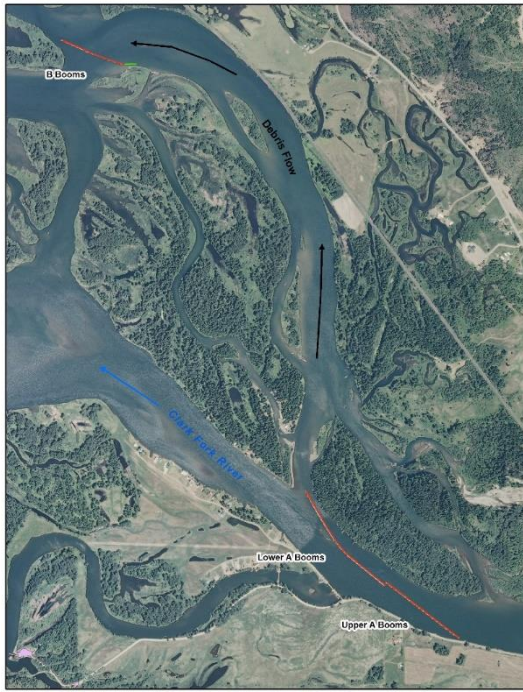
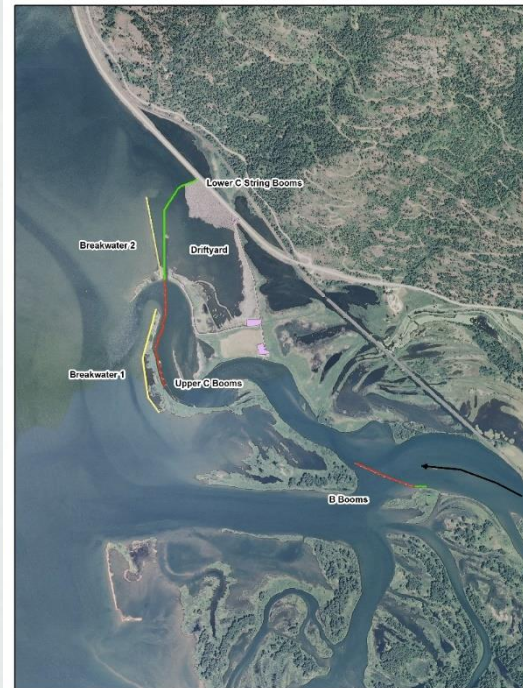
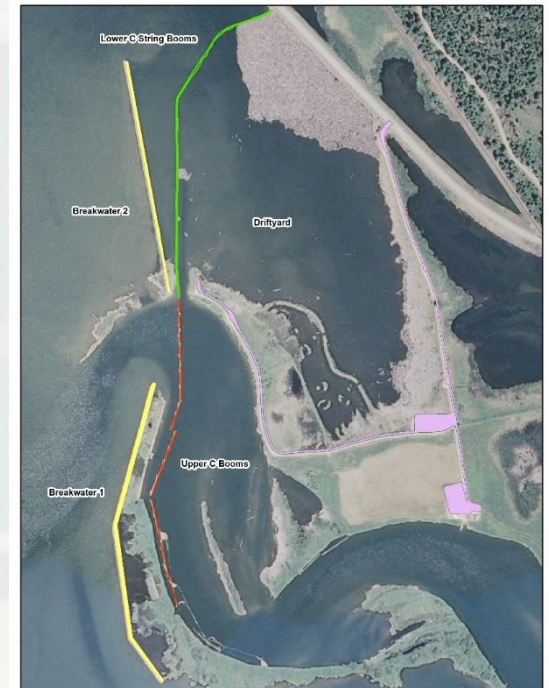
Upper and lower A Booms, segmented to allow boat passage. Directs current and drift from the main stem Clark Fork River into the north branch.

B Booms prevent drift from entering into a secondary channel; C Booms direct the drift into the holding facility. Breakwaters protect a portion from wind fetch.

Lower C string booms contain drift in the driftyard (drift holding facility). Drift floats in the facility at summer pool, and is grounded when the area is dewatered in winter.

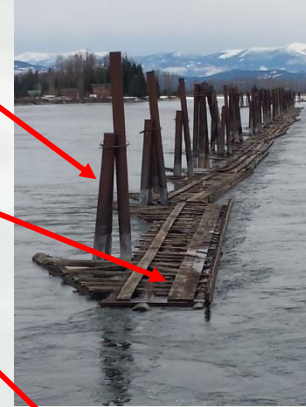
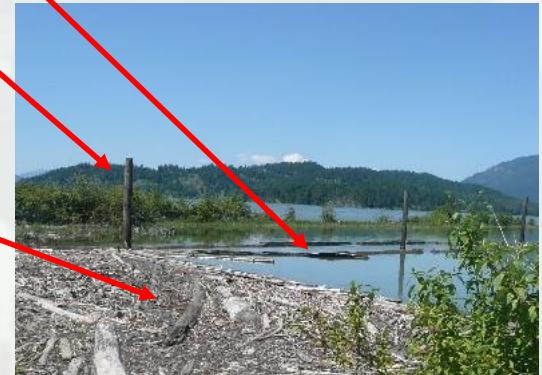
Dolphin – set of three pilings downstream of booms, made of steel, wood or plastic.

Shear boom – four sets of logs overlayed with connecting planks and hardware, wing sections that extend beyond downstream pilings. 100 to 200 feet in length. Diverts debris into holding facility.

String boom – single logs set end to end and chained together, connected to individual pilings. Used in low flow areas for directing drift and in the holding facility for drift containment.

Piling – individual piling made of steel, wood or plastic used in low flow areas and in the drift holding facility.

Drift holding facility (driftyard) – section of lake cordoned off by string booms and pilings. Boom system directs current, which in turn carries drift into the facility.
